CONNECTICUT RIVER BASIN
LEBANON, NEW HAMPSHIRE

MASCOMA DAM
NH 00155
NHWRB 134.09

PHASE I INSPECTION REPORT
NATIONAL DAM INSPECTION PROGRAM

JULY 1980

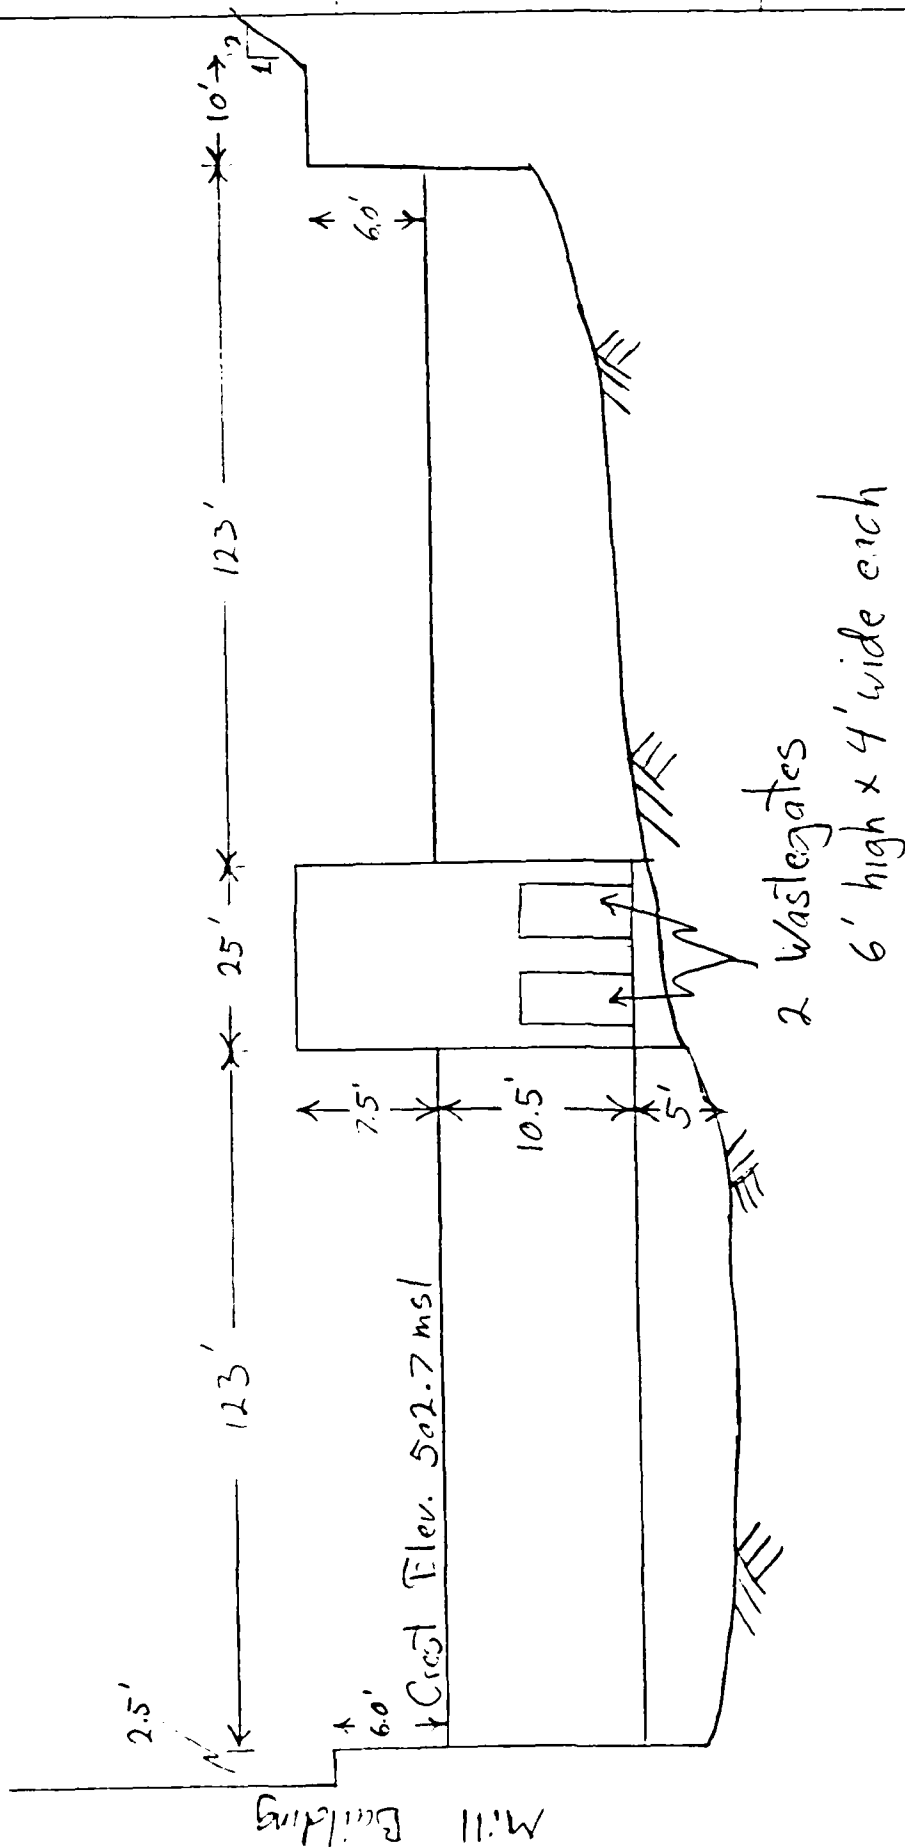
SCHEMATIC OF MASCOMA DAM (Looking upstream)
 Not to Scale

Based on NHWRB, "Inventory of Dams..." and field measurements.

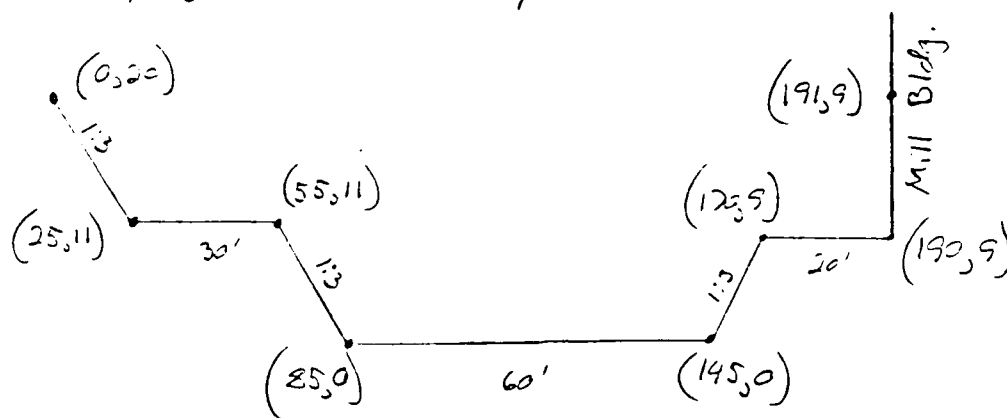
Mascoma R. 150' d/s of Mascoma Dam

Main Channel: $n = 0.04$ Slope: $S = 0.003$
Overbank: $n = 0.1$

A uniform flow rating table based on the section sketched above is shown on the next page. This was calculated using a simple BASIC program.

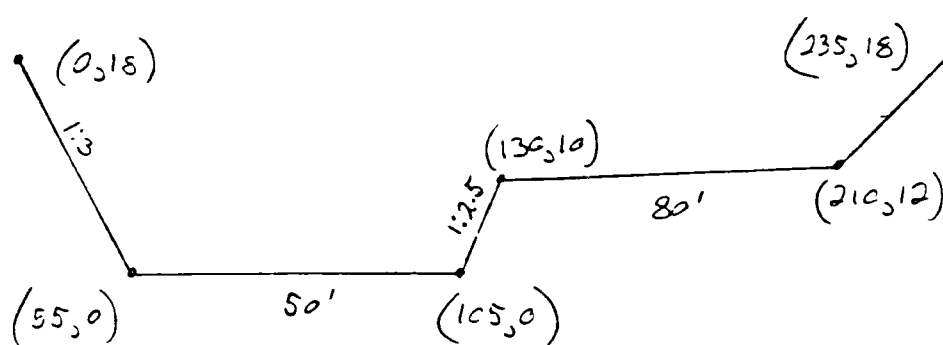
Mascoma R. 750' D/S of Mascoma Dam

A rating table for this reach of the Mascoma River, based on the approximate typical section sketched below, is shown on the next page.

Main Channel: $n = 0.4$ Overbank: $n = 0.1$
Slope: $S = 0.005$

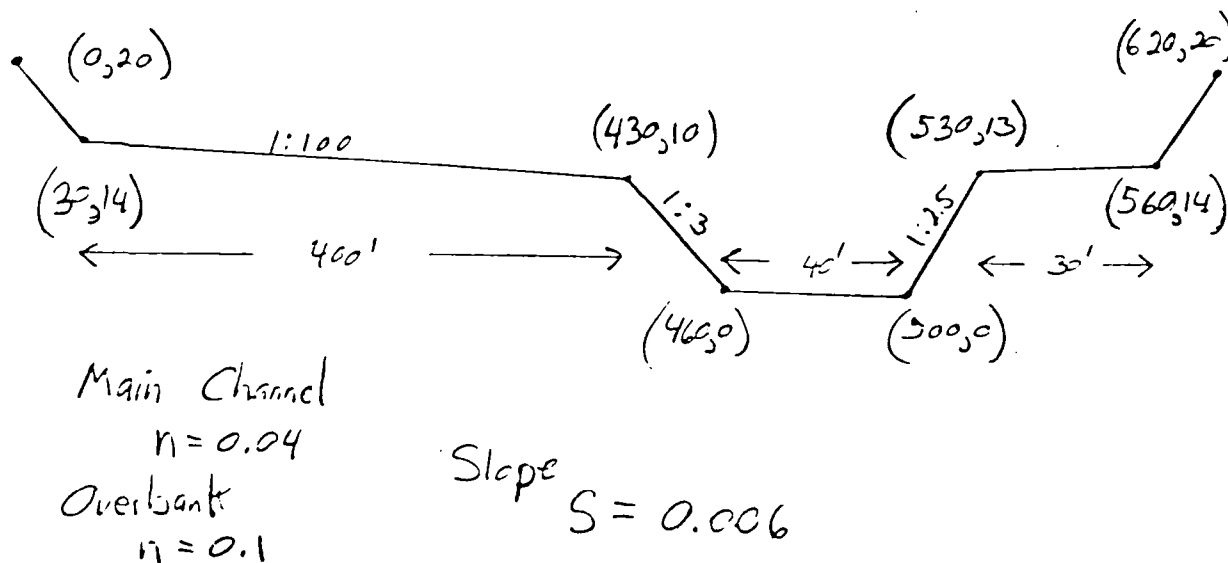
A rating table based on the section sketched below is shown on the next page.

Prior to Failure

Depth = 1.5' at $Q = 260$ cfs (Stream Rating)
